ARDM-2

(USS ALAMOGORDO)

MOORING INSPECTION REPORT

COOPER RIVER

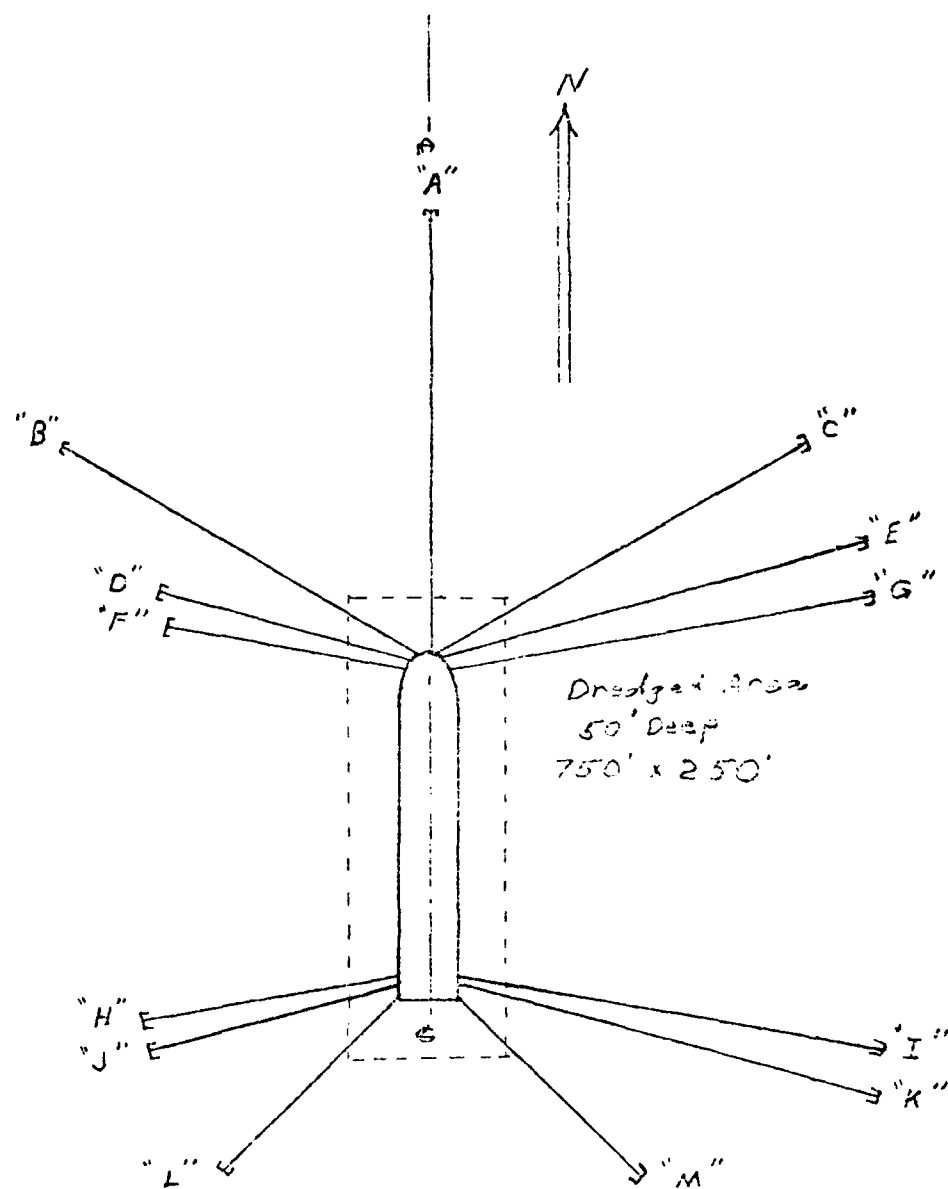
Figure 1. Schematic of Spread Mooring for ARDM-2
(USS ALAMOGORDO)

The measured chain diameter on the ARDM-2 mooring legs A, B, C, D, H, and M, (see Figure 1) exceed 90% of the original chain diameter and did not require downgrading in capacity. The measured diameter on the ARDM-2 mooring legs E, F, G, and K exceed 80% of the original chain diameter and should be downgraded in capacity to the next largest standard chain size. The ARDM-2 mooring legs I, J, and L were not inspected because auxiliary barges attached to the ARDM-2 presented a possible safety hazard to the divers. These chains should be tentatively downgraded in capacity to the next largest standard chain size.

- a. The chain capacity of legs E, F, G, and K should be downgraded to the next largest chain size on the basis of actual measurements and the chain capacity of legs I, J, and L should be tentatively downgraded.

- b. The mooring capacity of the ARDM-2 in the Cooper River exceeds the design capacity of the moor and does not require removal or replacement of any mooring components at the present time.

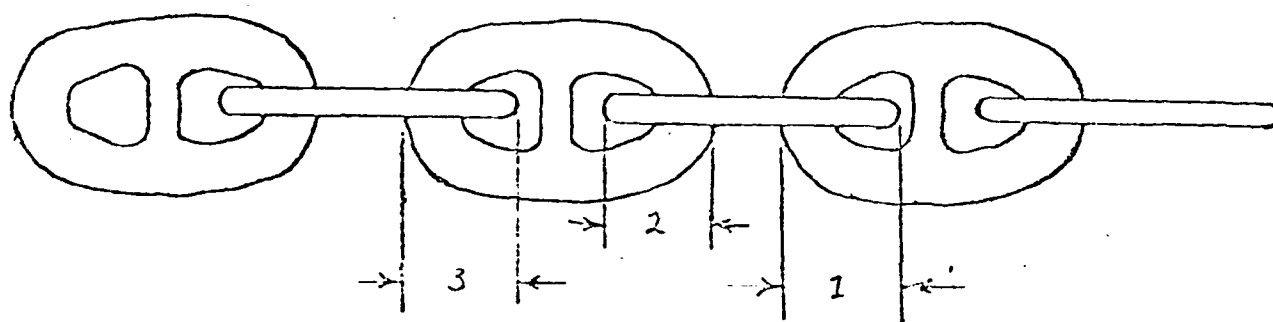
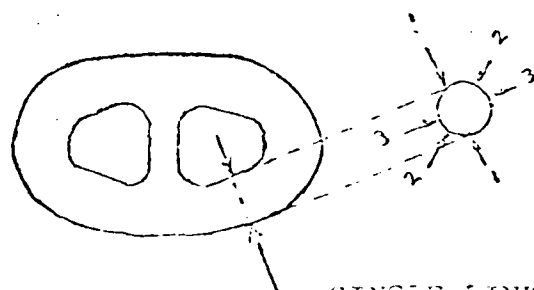
FIGURE 6

original diameter should be replaced. Single and double link measurements should be performed as in figure 6 at a randomly selected set of links, at areas listed below. Single link measurements on the wire diameter of a single A-link shall be performed to detect corrosion loss; double link measurements shall be taken where the two A-links contact in order to detect wear. Single link measurements should be made on three different diameters on the same approximate cross-section as shown in figure 6. The double link measurements should be made on three adjoining links as shown in figure 6.
